Field Verification of Liners from Sanitary Landfills

EMCON Associates, San Jose, CA

EPA-600/2-83-046
June 1983

FIELD VERIFICATION OF LINERS FROM SANITARY LANDFILLS

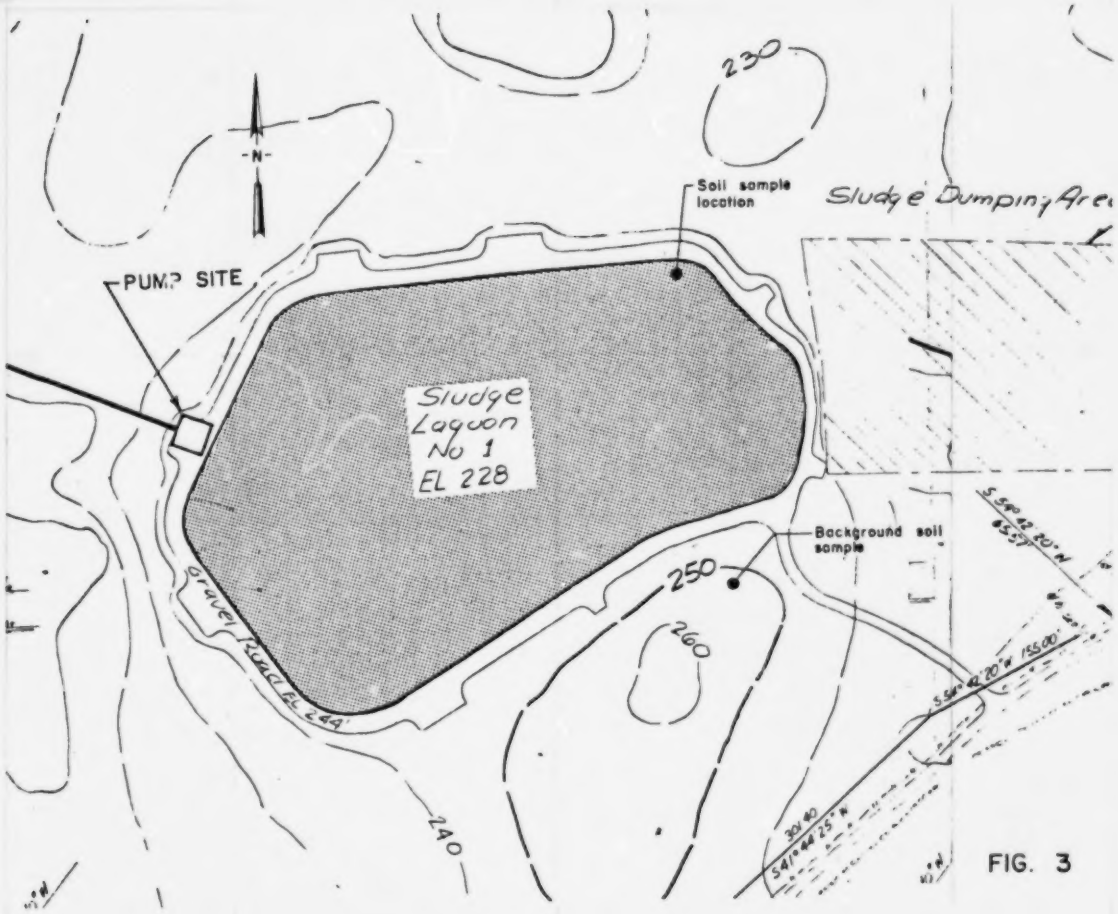
Figure 2. Site plan, New England sludge lagoon (SI)

During the examination of the site on the first trip, several areas of the liner were bare and completely exposed to the weather; also, the liner had split open in several places along the southwest edge (Figure 2). Round boulders some about 31 cm (1 ft) in diameter, were apparent in several places on the southwest edge of the pond beneath the surface of the liner. In such cases, the liner was stretched tautly over them as a result of the loss of plasticizer and shrinkage that had occurred in the PVC compound. The exposed liner had become brittle; in fact, it fragmented when touched, even though the liner was in the sun and warm. Such brittleness is indicative of considerable degradation of the PVC as well as loss of plasticizer.

The liner sample taken from the inside surface of the embankment and facing the sludge was distorted and torn in spite of the 16 cm (6 in.) sand base. Boulders either had worked their way out of the soil, or the sand had sloughed. The tear of the liner may have been the result of the sludge mass moving downward as it was being moved from the pond.

Also, an encrustation had developed at various places on the surface of the liner. When the liner samples were returned to the laboratory, dilute hydrochloric acid was applied to the encrustations. Fizzing resulted, which indicated that a calcium carbonate deposit was building up on the liner.

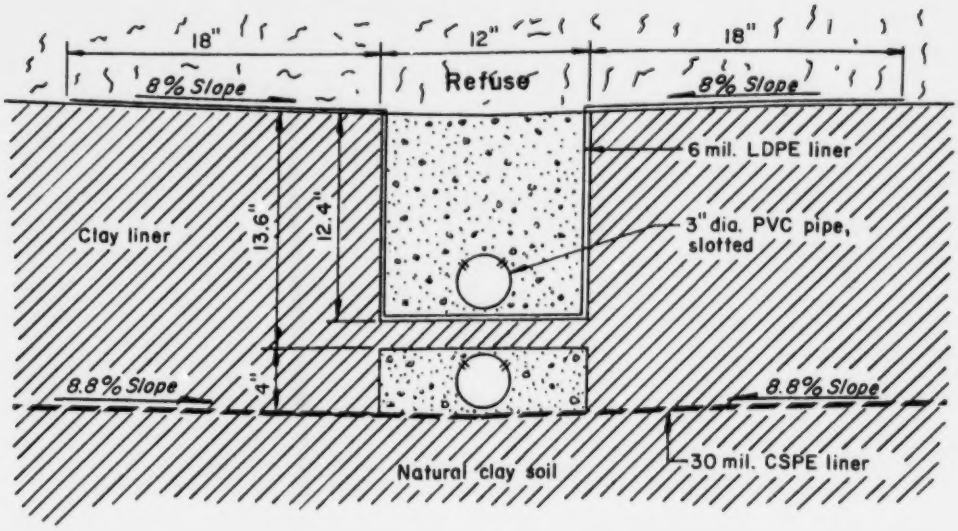
Figure 3. Cross Section of TC-1 at Observation Bulkhead

The clay liner between the refuse fill and the CSPE liner varied in thickness from 44 to 62 cm (17 to 24 in.). The liner was composed of a slightly sandy, moderately plastic clay containing limestone rock fragments up to 26 cm (10 in.) long. The clay was classified as a CL by the Unified Soil Classification System, with an average liquid limit of 42 and a plasticity index of 20. Rock fragments lay parallel to the liner surface. Average in-place dry density was 99 pcf, and average moisture content was 25 percent. Permeability ranged from 4 to 5 x 10^{-7} cm/sec for in-place tests; in laboratory tests, it was 2 x 10^{-8} cm/sec. These and other soil testing data are summarized in Table 6. The liner was light brown-gray to a depth of 31 to 36 cm (12 to 14 in.), where it abruptly changed to a more natural orange-tan for the remainder of its thickness. No visual signs of cracking, channeling, or unusual changes in texture or consistency were noted in any of the excavations. Chemical analyses of the clay liner in TC-1 (Figures 4 and 5) indicated that it provided effective leachate containment. Some leachate had collected below the clay liner. But this leakage resulted from a small perforation in the clay separating upper and lower drains, not from liner failure. The uniform contours of the perforation suggest accidental puncturing of the clay surface during cell preparation.

below the cell (See Figure 3). A slotted collection pipe surrounded by gravel was placed directly above the CSPE liner in the clay liner beneath the refuse.

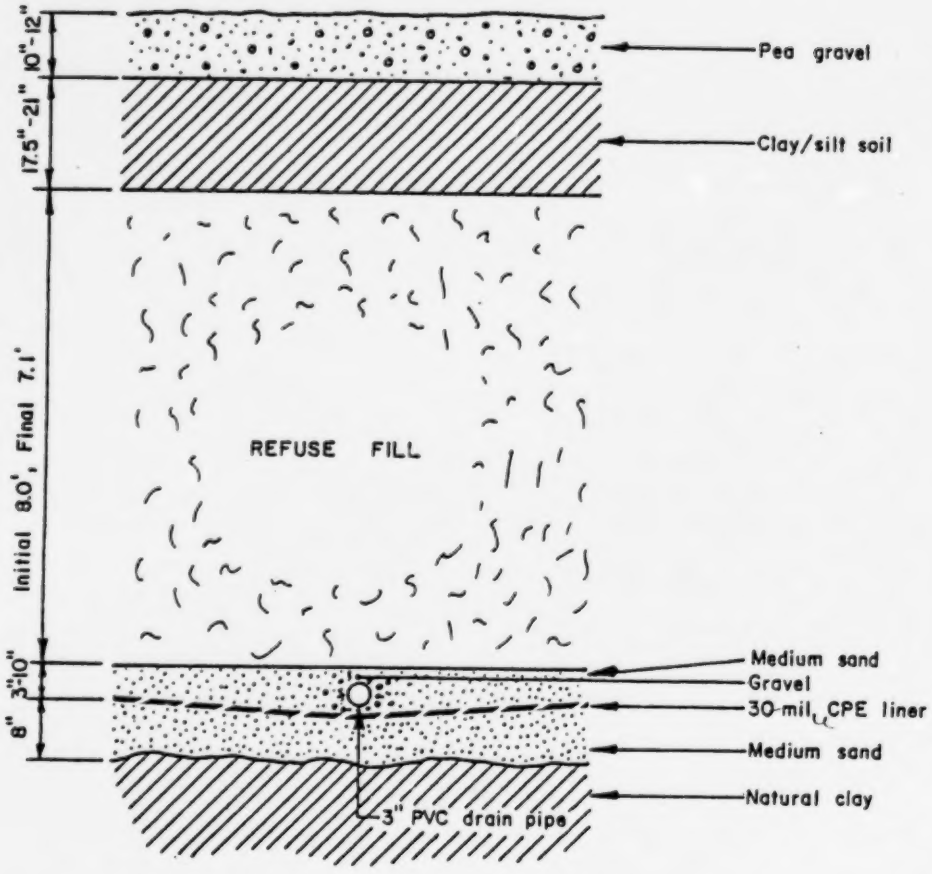
Figure 6. Test Cell Construction Details for TC-2D.

An excavation was made into a orange-tan clay underlying TC-2D. An excavation was made into a layer of sand and a section of clay underlying the CPE liner in TC-2D (see Figure 6). The sand, which was immediately beneath the CPE liner, was a light tan except for a 1.3- to 1.9-cm (1/2-to 3/4-in.) gray zone at the point of contact with the liner. Exploratory trenches had found the CPE liner to be under an upward hydrostatic pressure from fluids in the underlying sand. Analysis of fluid samples indicated, however, that the water did not contain leachate. Beneath the sand was a thick, natural clay section of moderate to high plasticity classified as CL-CH by the Unified Soil Classification System. The upper 2.5 to 5.1 cm (1 to 2 in.) were a mottled gray-green, with the remainder of the exposed clay a natural orange-tan. Soil test data are summarized in Table 13.
